# **Journal of Power Sources**

# Detecting and localizing failure points in proton exchange membrane fuel cells using IR thermography

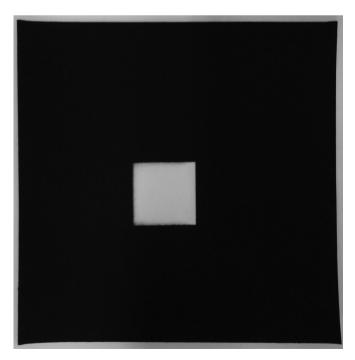
**Fig. 1.** ETFE decal holding an ultrasonically sprayed 50 cm<sup>2</sup> electrode that contained a 2 cm<sup>2</sup> 100% catalyst loading reduction defect, i.e. the white uncoated area.

was applied; the total force was calculated with respect to the size of the Gylon sheets. MEAs with artificially induced cathode electrode coating defects were created by masking off a square area of 2 cm<sup>2</sup> size near the center of the electrode during the ultrasonic spray process. As shown in Fig. 1, this created a 100% catalyst loading reduction of defined size, geometry, and location.
